FINAL Five-Year Review Report

**Fourth Five-Year Review Report
for
Standard Steel & Metals Salvage Yard (USDOT)**

Anchorage, Alaska

April 2018

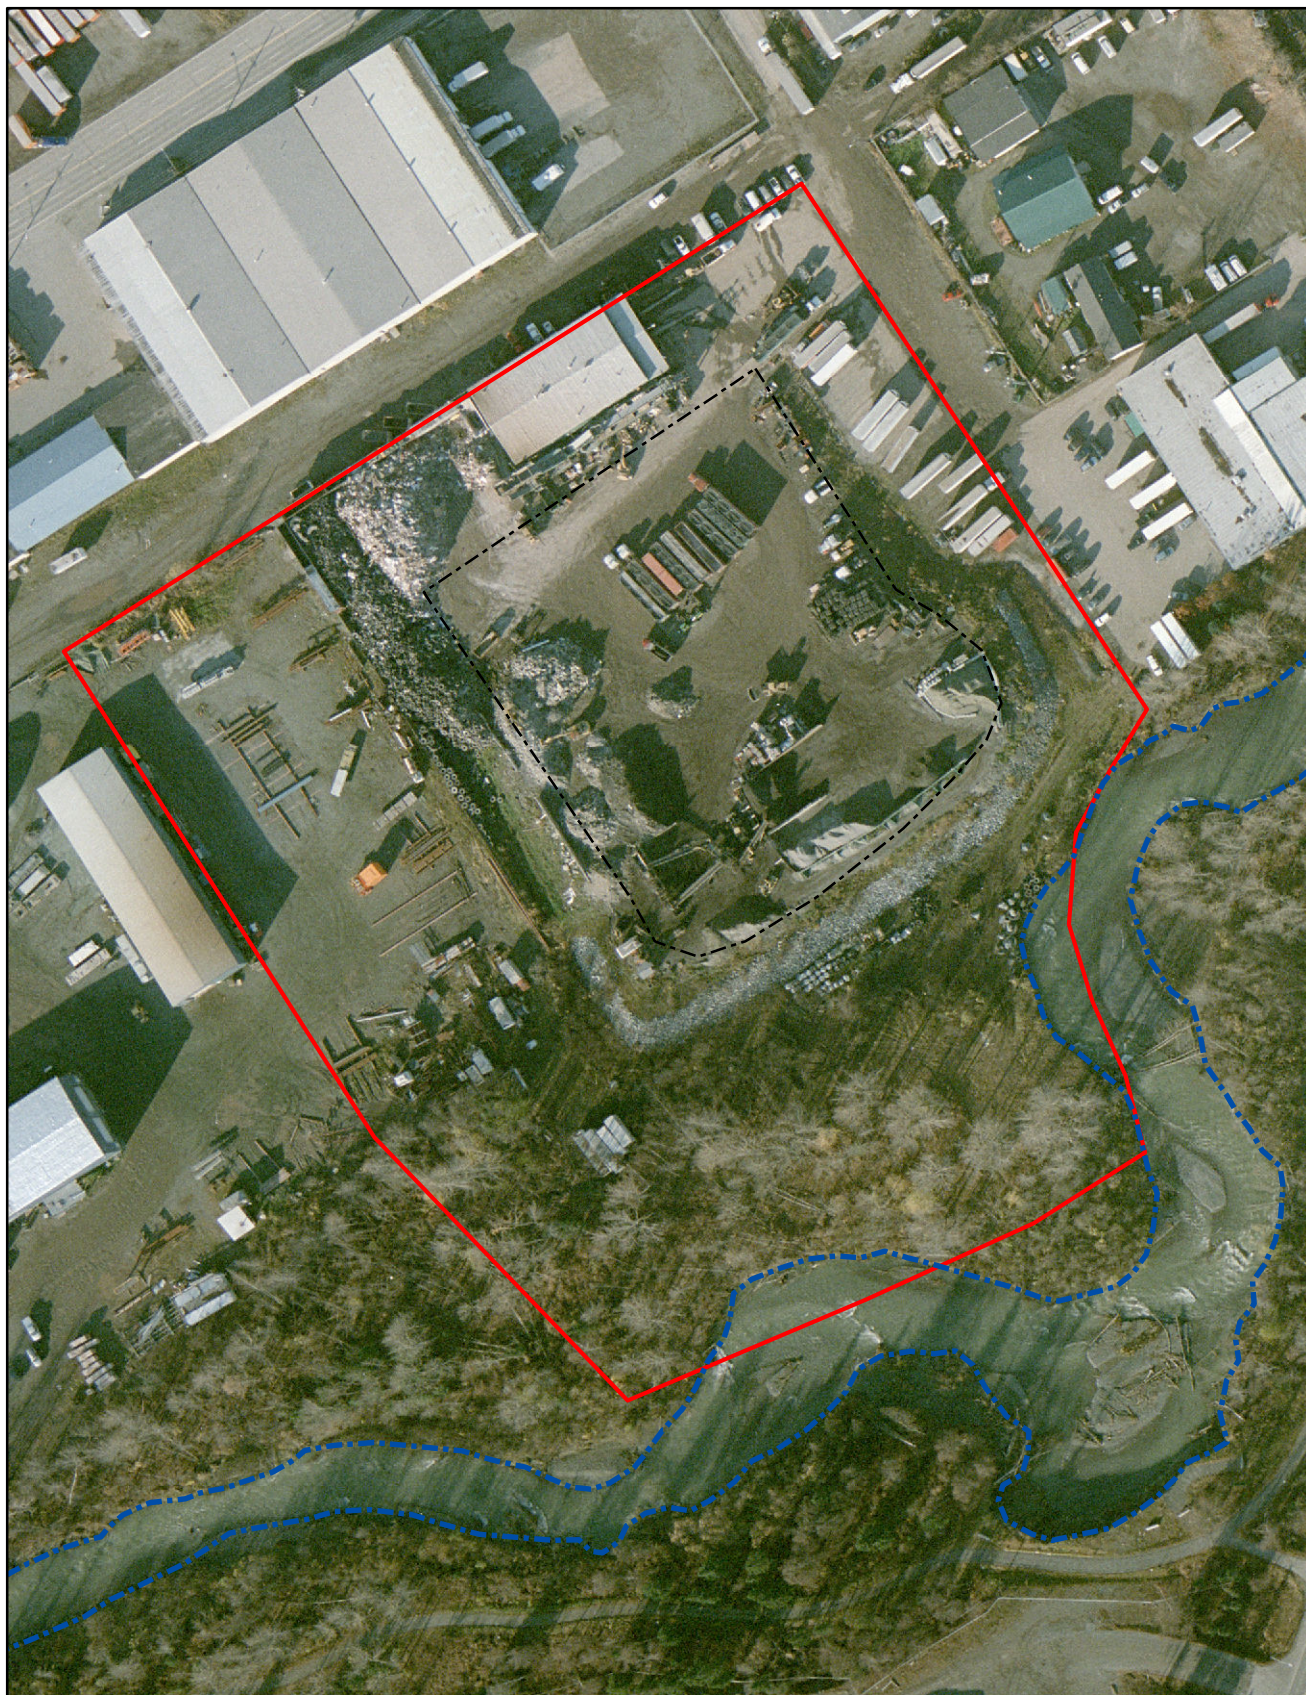
Ship Creek continues to erode its banks. A portion of the north bank nearest to the consolidation cell which eroded during the 2012 flood continues to migrate towards the landfill cap. Aerial photographs from August 1995 (Figure 5), October 2012 (Figure 6), and September 2017 (Figure 7) were reviewed to determine if significant stream channel erosion had caused the stream to migrate towards the landfill consolidation cell since it was constructed. The 1995 aerial photograph depicts the stream channel prior to the construction of the consolidation cell; the 2012 aerial shows the impact from the last major flood event; the 2017 aerial is the most current photograph of the stream channel. Although the stream channel morphology has naturally changed since 1995, a comparison of the aerial photographs (Figure 8) appears to demonstrate the stream channel has only slightly migrated towards the landfill consolidation cell.

Recommendation: Continued monitoring of the Ship Creek streambank should be conducted during the next Five Year Review, including visual inspection and aerial photo comparisons. The consolidation cell was designed to allow for normal geologic processes should the entire channel of Ship Creek migrate northwards. The consolidation cell's erosion control wall construction extends well below the bottom elevation of Ship Creek and is
